ASSET SURVEY

CALNE WITHOUT PARISH COUNCIL

MARCH 2025

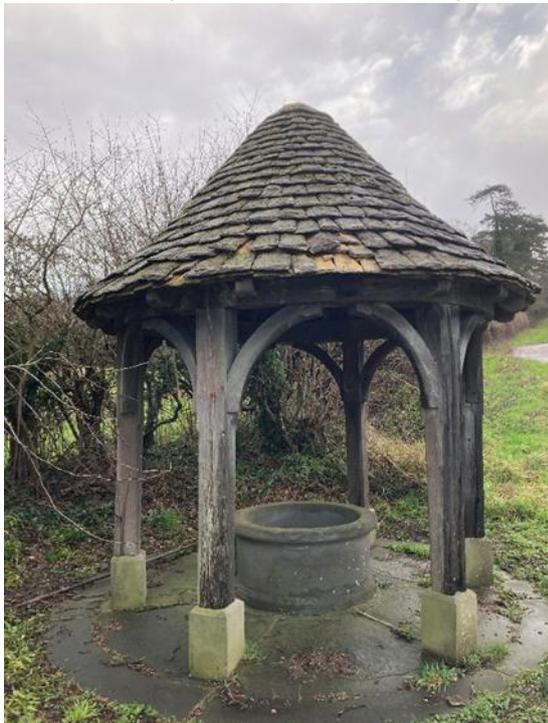
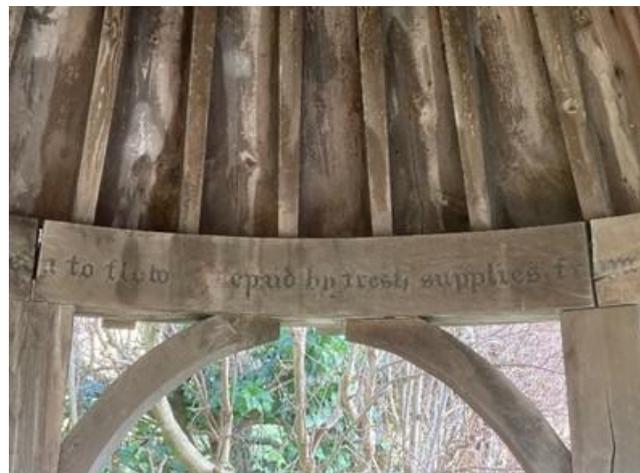
Asset: The Well House

Well-house, c1900, circular, 6 timber posts with arched braces carrying conical stone slate roof with ball finial. Circular pennant stone well-head with radiating pennant stone paving around. Top plate with painted inscription 'Here quench your thirst and mark in me an emblem of true charity who while my bounty bestow am neither heard nor seen to flow. Repaid by fresh supplies from heaven for every cup of water given'. Identical to well-houses set up by the Poynder family of Hartham Park at Biddestone, Colerne and Hilmarton, Wilts.

Condition: Poor

“At the inspection of 2022 it was noted that the oak finial had split. One half of the finial has now broken away and the lead capping to the top of the cone is dislodged. Recent storms and been severe and it seems likely that this was storm damage, possibly aggravated by overhanging branches close to the roof.”

- *Cut back all branches overhanging or close to the structure to minimise the risk of physical damage to the roof tiles and finial.*
- *Carefully take down the remains of the finial for repair or replacement.*
- *At the apex check all the lead fixings and make secure prior to the refixing of the existing lead capping. It may be desirable to provide additional fixings and this can be determined when repair is undertaken.*
- *Use the remains of the oak finial as the template for a replacement, either in oak or a suitable close-grained indigenous timber alternative. Refix, pinned as the existing. It may be possible to repair the finial but this seems unlikely and may not prove long-lasting.*
- *Check lower course of tiles at the roadside and realign. (Appear to have been disturbed).*
- *Glue small piece of oak (to follow the grain to the base of the post to minimise weathering).”*

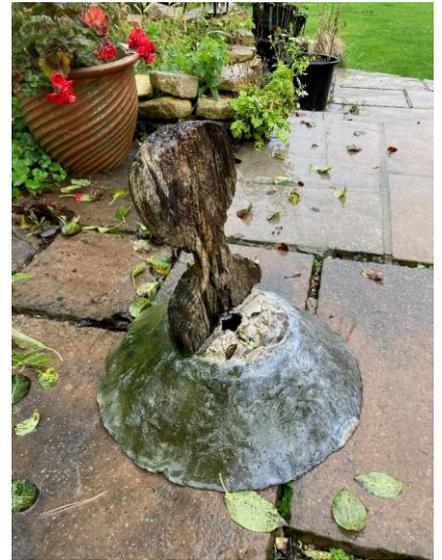
- In May 2024, the tree that had grown up in the hedge next to the well house was removed by the Bowood Estate, removing the chance of further damage from its branches.
- In September 2024, the rest of the finial and the lead apex cap fell from the roof and are held by the parish council.
- In December 2024, a large branch fell from the ancient oak tree in the hedge to the north west of the well house, dislodging a number of stone tiles. The branch was cleared by the Bowood Estate.

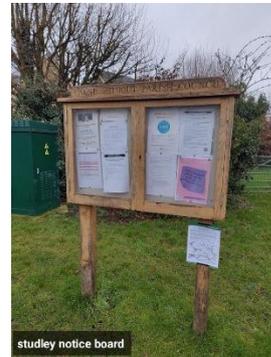
Asset: Studley Noticeboard

Condition notes: some condensation on inside of glass, notices still visible.

Recommendations for remedial work (if any): maintain annual maintenance (clean and re-oil).

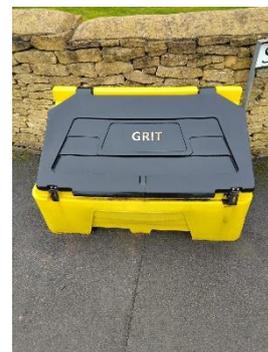
Condition: Very Good

Condition notes: Installed in November 2021. Bin is full.

Recommendations for remedial work (if any): None.

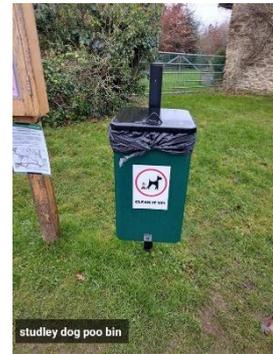
Description: Dog Waste Bin

Condition: Installed August 2022

Condition notes: Good Condition.

Recommendations for remedial work (if any): None.

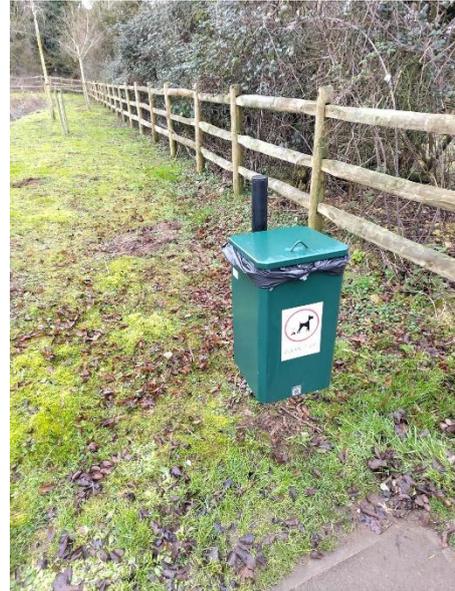
Description: Dog waste bin (green).

Condition: Very Good

Condition notes: Installed in 2020, condition excellent.

Recommendations for remedial work (if any): none.

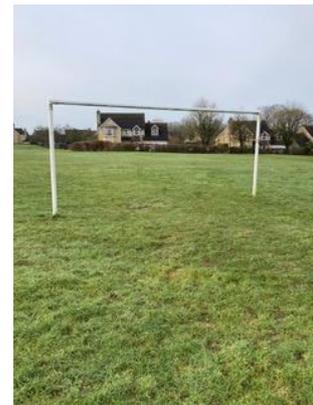
Description: Two sets of goal posts on public open space.

Condition: Fair

Condition notes: Inspected by ROSPA Play Safety on 24th September 2024. Minor issues only identified. See separate report.

Recommendations for remedial work (if any): No major issues..

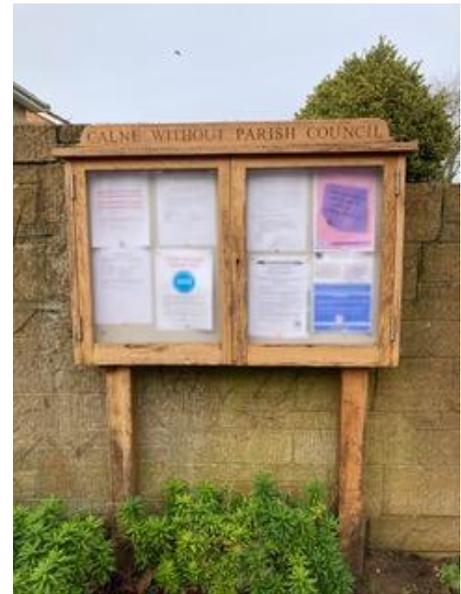
Description: Parish Council noticeboard.
(Key Holder: Parish Clerk)

Condition: Good

Condition notes: No issues.

Recommendations for remedial work (if any): maintain annual maintenance (clean and re-oil).

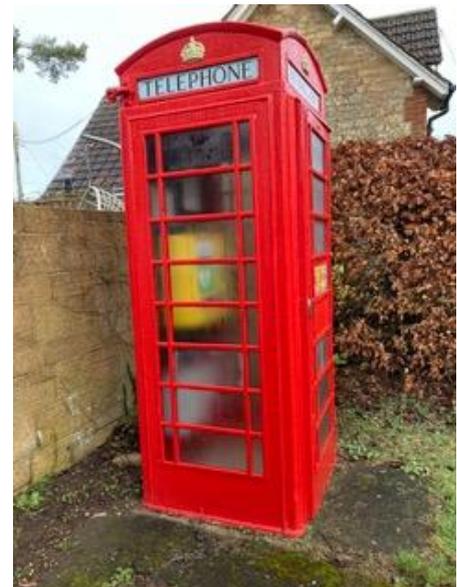
Description: Redundant red telephone kiosk, now accommodating a Defibrillator installation.

Condition: Good

Condition notes: full refurbishment and repaint reglaze completed within the two years,

Recommendations for remedial work (if any): none required this year.

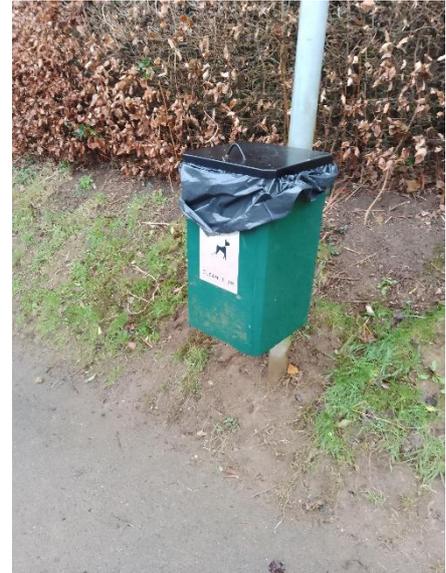
Description: Green dog waste bin.

Condition : Good

Condition notes: Good condition

Recommendations for remedial work (if any): None.

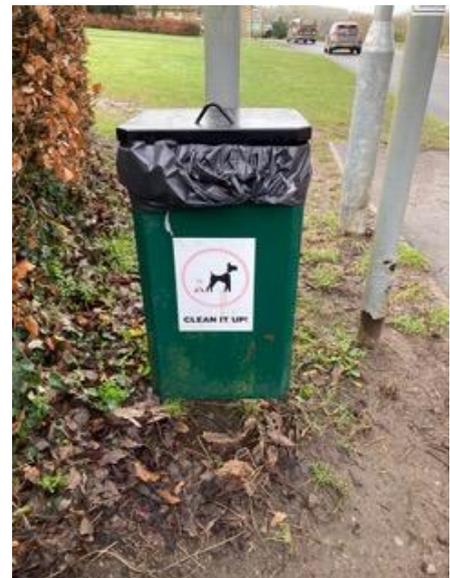
Description: Green dog waste bin.

Condition: Good

Condition notes: bin lowered since last inspection to make emptying easier

Recommendations for remedial work (if any): none

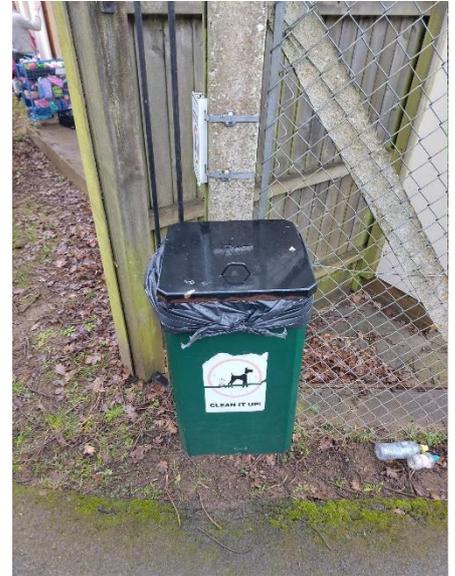
Asset: Dog Waste Bin

Condition notes: Paint on the lid is starting to peel off. Lid still closes.

Recommendations for remedial work (if any): Monitor the lid and replace when condition deteriorates further.

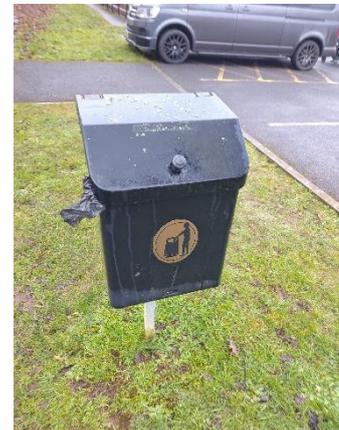
Asset: General Waste Bin

Condition notes: Evidence of rust at hinges on the lid

Recommendations for remedial work (if any): Monitor condition of lid.

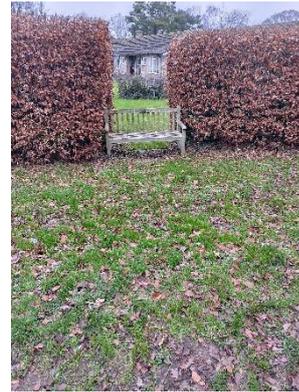
Description: Wooden bench
Condition: Good
Condition notes: No issues
Recommendations for remedial work (if any): None.

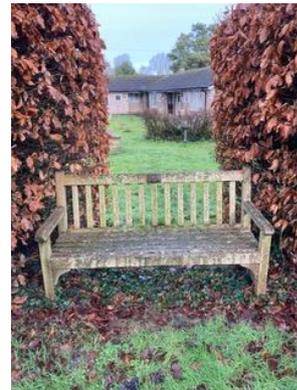
Description: Wooden bench
Condition: Good
Condition notes: No issues
Recommendations for remedial work (if any): None.

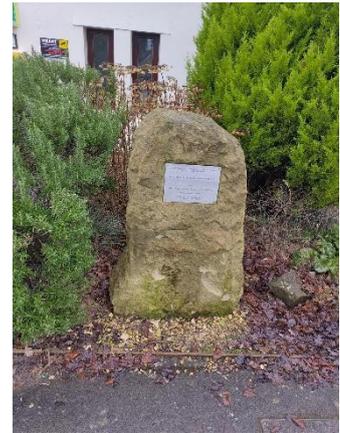
Asset: Commemorative stone
Location: Lansdowne Hall, Derry Hill
Ward: West Ward
What3Words Location: suitable.tickling.adapt
Date of Assessment: 23rd January 2025
Description: commemorative stone and plaque. Installed June 2022.
Condition (delete as applicable): Very Good
Condition notes: Some weathering of stone as expected.
Recommendations for remedial work (if any): none required.

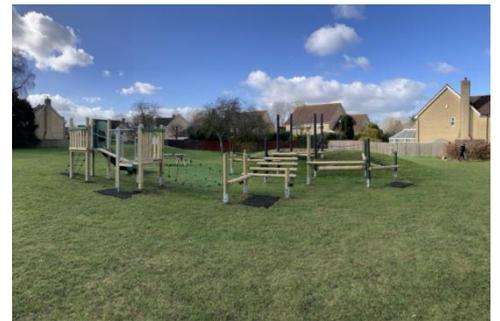
Asset: Play equipment
Location: Petty Acre, Derry Hill
Ward: West Ward
What3Words Location: ///universe.powder.opened
Date of Assessment: installed Feb 25
Description: tangle web and play tower.
Condition (delete as applicable): As new
Condition notes: As new.
Recommendations for remedial work (if any): none required.

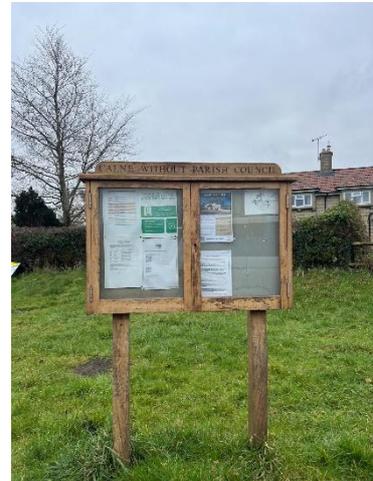
Asset: Stockley Noticeboard

Condition notes: Could do with a sand and varnish.

Recommendations for remedial work (if any): maintain annual maintenance (clean and re-oil).

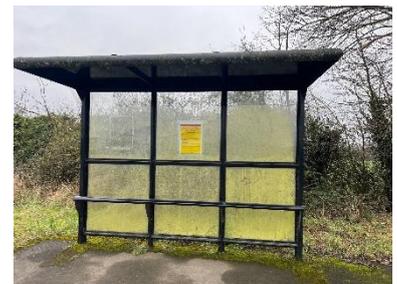
Asset: Bus Shelter

Condition notes: Dirty condition, mould and moss growing on top

Recommendations for remedial work (if any): Needs to be cleaned.

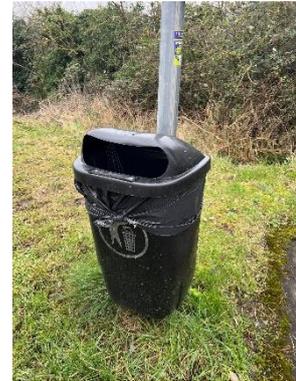
Asset: Litter Bin
Location: Stockley
Ward: Middle Ward
What3Words Location: enclosing.forgiving.trim
Date of Assessment: 12th February 2025
Description: Black litter bin attached to bus stop.
Condition: Very Good.
Condition notes: No issues.
Recommendations for remedial work (if any): None

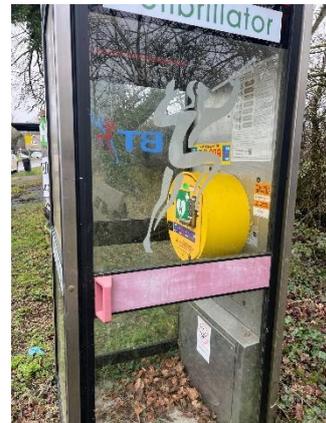
Asset: Stockley Phone Kiosk
Location: Stockley
Ward: Middle Ward
What3Words Location: locate.dubbing.redouble
Date of Assessment: 12th February 2025
Description: Redundant modern telephone kiosk, now accommodating a Defibrillator installation.
Condition: Fair
Condition notes: Fundamental condition is good,
Recommendations for remedial work (if any): none

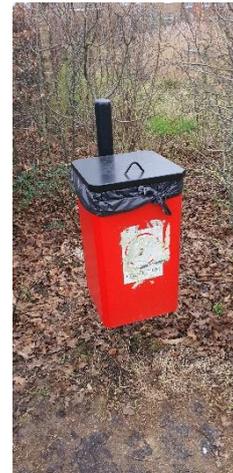
Asset: Dog Waste Bin

Condition notes: Sticker could be replaced on the front

Recommendations for remedial work (if any): regularly full (but emptied twice a week)

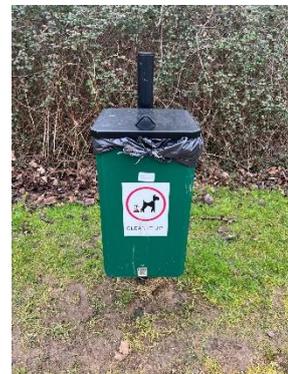
Asset: Dog waste Bin
Location: Acorn Lane, Cherhill View
Ward: Middle Ward
What3Words Location: ///fiery.requiring.burying
Date of Assessment: 12th February 2025
Description: green dog waste bin, emptied twice per week
Condition: Very Good.
Condition notes: No issues.
Recommendations for remedial work (if any): None

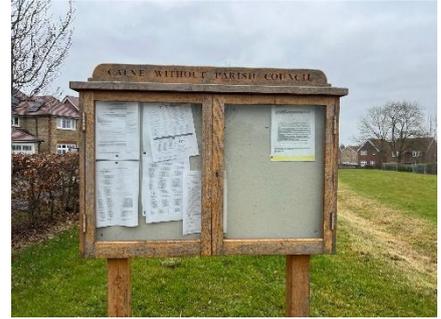
Description: Parish Council Noticeboard
(Keyholder: Parish Clerk)

Condition: Good

Condition notes: Good Condition.

Recommendations for remedial work (if any): no recommendations

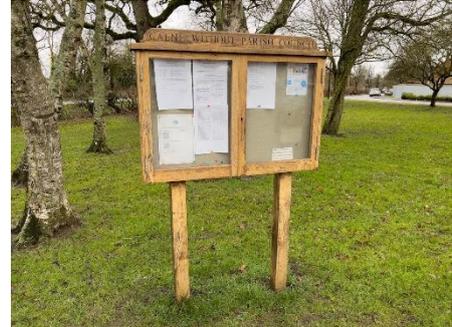
Asset: Lower Compton Notice Board

Condition notes: no issues noted.

Recommendations for remedial work (if any): Wood will probably need some treatment in the summer.

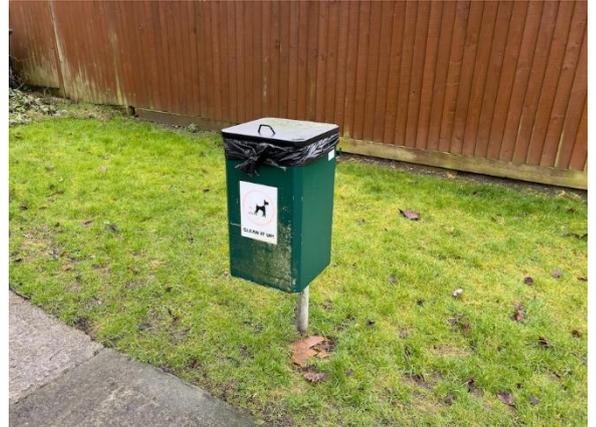
Asset: Dog waste bin
Location: Whittle Avenue, Lower Compton
Ward: East Ward
What3Words Location: wakes.blurs.watch
Date of Assessment: 21st February 2025
Description: Green dog waste bin.
Condition (delete as applicable): Good
Condition notes: No issues.
Recommendations for remedial work (if any): none,

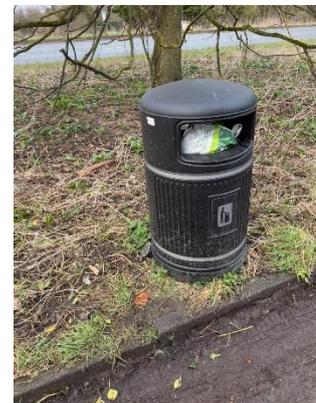
Asset: Waste bin
Location: Layby off the A4 at Cherhill
Ward: East Ward
What3Words Location: crafts.refrained.tweaked
Date of Assessment: 12th February 2025
Description: Black waste bin. Installed Nov 22
Condition (delete as applicable): Good
Condition notes: No issues.
Recommendations for remedial work (if any): none noted

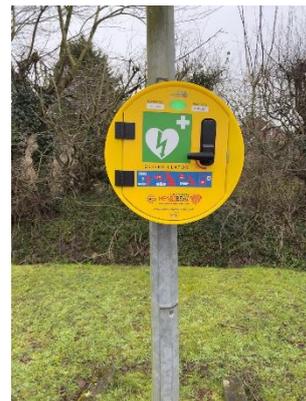
Asset: Defibrillator
Location: Trenchard Road, Lower Compton
Ward: East Ward
What3Words Location: ///drops.putter.stance
Date of Assessment: 12th February 2025
Description: Installed late 24
Condition (delete as applicable): Very Good
Condition notes: No issues.
Recommendations for remedial work (if any): none noted

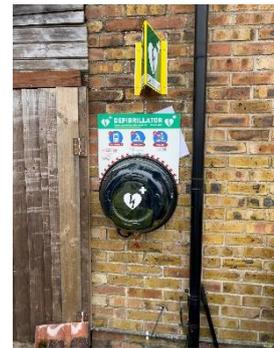
Date of Assessment: 12th February 2025
Description: Installed late 24
Condition (delete as applicable): Very Good
Condition notes: No issues.
Recommendations for remedial work (if any): none noted

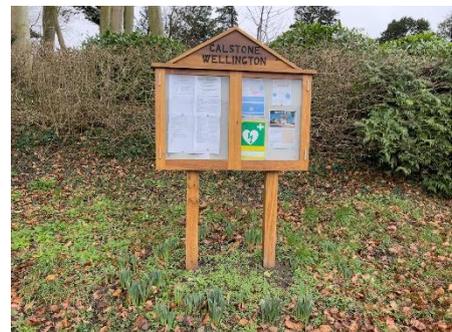
Date of Assessment: 21st February 2025
Description: Parish Council Noticeboard
(Keyholder: Cllr Price)
Condition: Good
Condition notes: door sticking

Recommendations for remedial work (if any): Wood will probably need some treatment in the summer.

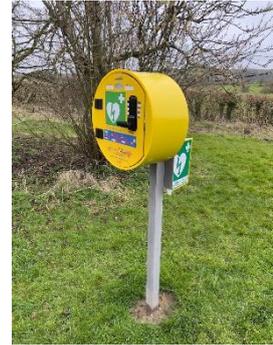
Condition (delete as applicable): Very Good

Condition notes: No issues.

Recommendations for remedial work (if any): none noted

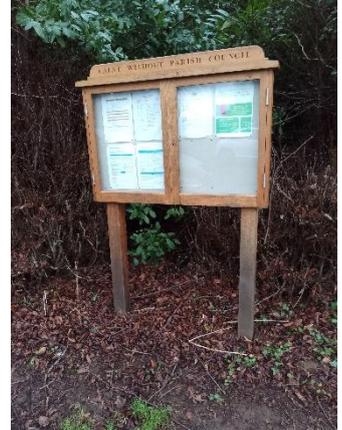
Condition (delete as applicable): Good

Condition notes: Board has weathered in over the last year, no issues.

Recommendations for remedial work (if any): NA

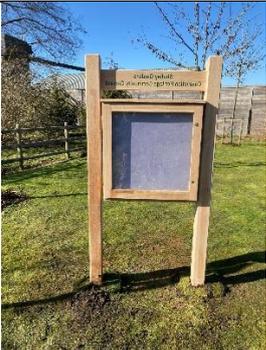
Noticeboard	Installed Feb 25

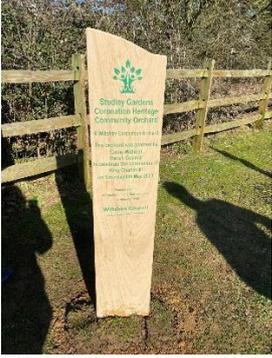
Monolith	Installed Feb 25
