ASSET SURVEY

CALNE WITHOUT PARISH COUNCIL

JANUARY 2024

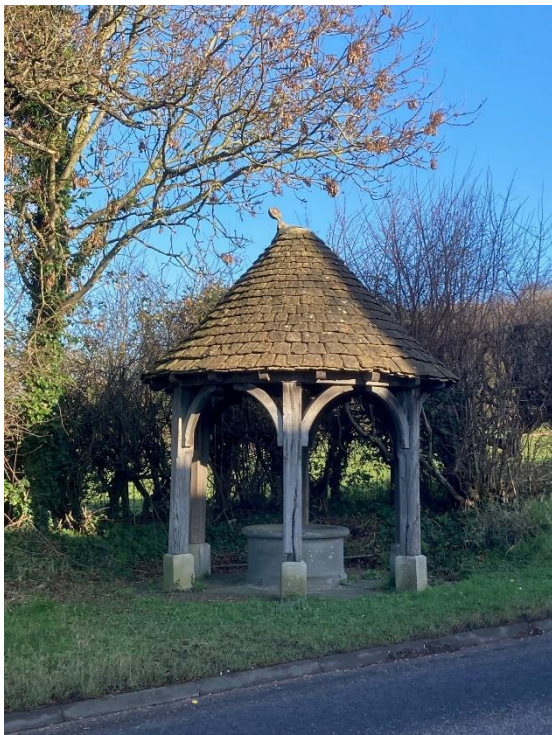
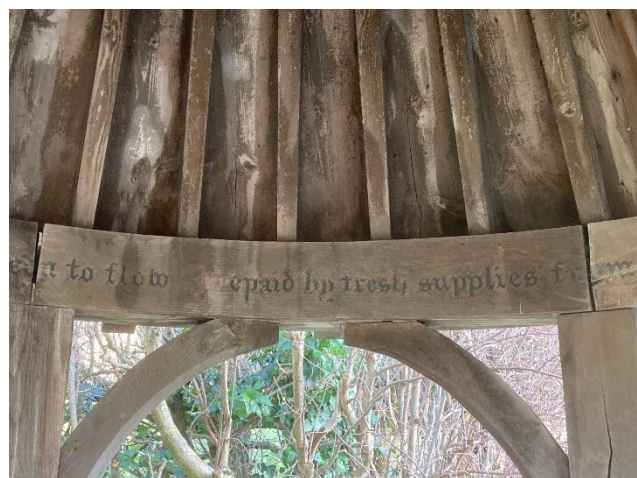
Asset: The Well House

Well-house, c1900, circular, 6 timber posts with arched braces carrying conical stone slate roof with ball finial. Circular pennant stone well-head with radiating pennant stone paving around. Top plate with painted inscription 'Here quench your thirst and mark in me an emblem of true charity who while my bounty bestow am neither heard nor seen to flow. Repaid by fresh supplies from heaven for every cup of water given'. Identical to well-houses set up by the Poynder family of Hartham Park at Biddestone, Colerne and Hilmarton, Wilts.

Condition: Fair

Significant repairs were undertaken to the Well House in 2002. The Parish Council commissioned Wiltshire Historic Buildings Trusts to undertake a condition survey in 2020. The key findings from that were:

- The structure and stone tile roof remained intact.
- The oak ball finial had split through natural movement.
- Some of the repointing to the stone paving was loose and beginning to break away.
- No items required immediate attention.
- It was recommended to cut back the tree and hedge growth around the building to avoid damage during high winds.

Tree and hedge overgrowth has previously been cut back but this needs to be undertaken again.

It is recommended that the Parish Council arranges for a further survey to be undertaken by the Wiltshire Historic Buildings Trust with recommendations for remedial work to be implemented.

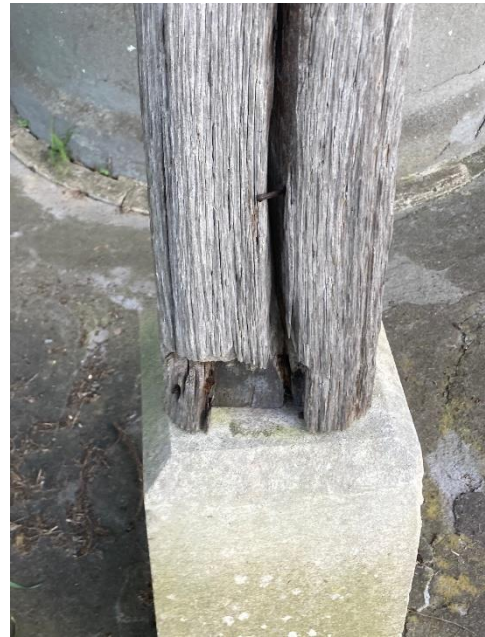
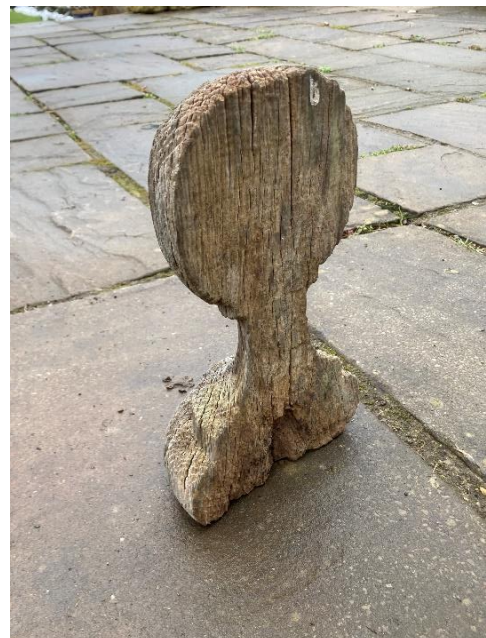
The lettering around the inside of the structure is starting to fade in places, as can be seen from the photograph.

Part of the foot of one timber post has broken away, and the post is beginning to split, as shown in the photograph.

In addition, half of the oak finial has fallen off the apex of the structure and is in storage.

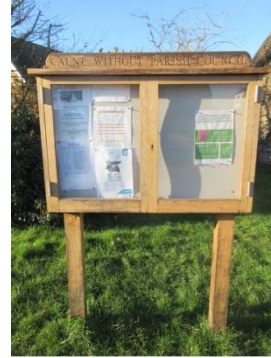
Asset: Studley Noticeboard

Condition: Good

Condition notes: No issues.

Recommendations for remedial work (if any): maintain annual maintenance (clean and re-oil).

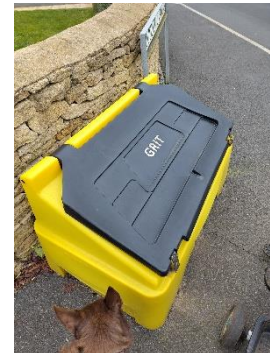
Asset: Studley Grit Bin

Condition: Very Good

Condition notes: Installed in November 2021. Bin is full.

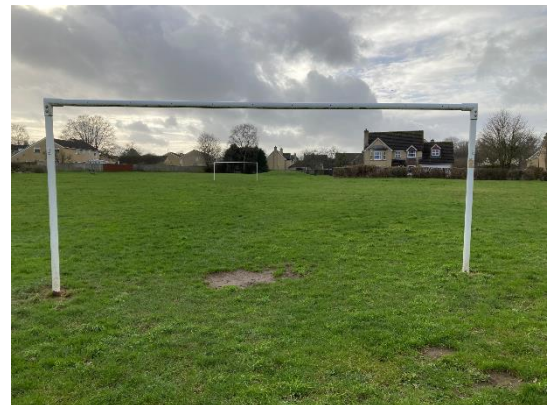
Asset: Petty Acre Goal Posts

Condition: Fair

Condition notes: Inspected by ROSPA Play Safety on 4th October 2023. Minor issues only identified. See separate report.

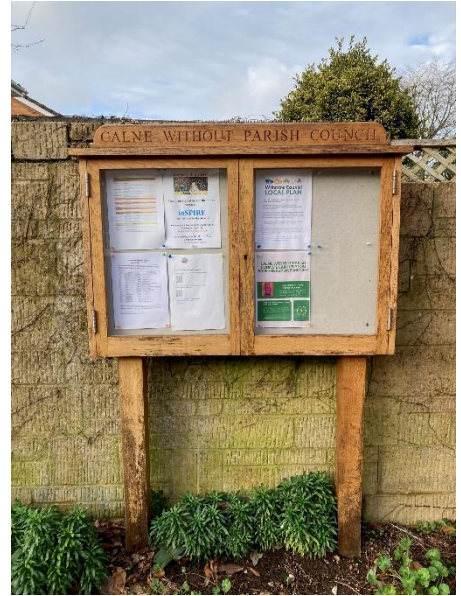
Asset: Derry Hill Noticeboard

Condition: Good

Condition notes: No issues.

Recommendations for remedial work (if any): maintain annual maintenance (clean and re-oil).

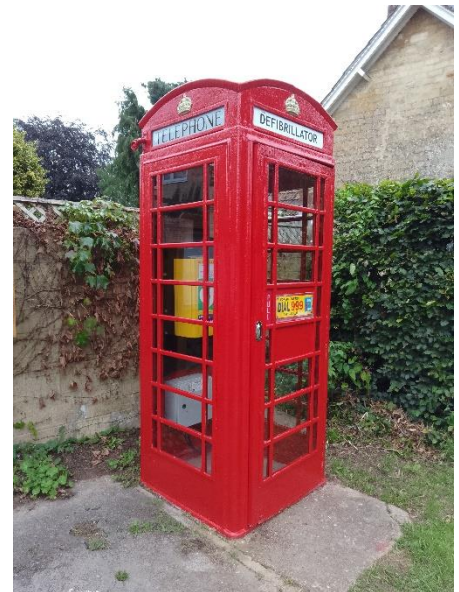
Asset: Derry Hill Phone Kiosk

Condition: Good

Condition notes: full refurbishment and repaint reglaze completed within the last year,

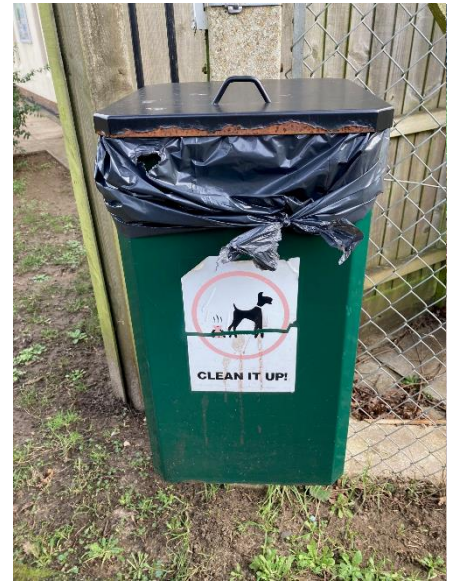
Asset: Dog Waste Bin

Condition: Fair

Condition notes: Paint on the lid is starting to peel off. Lid still closes.

Recommendations for remedial work (if any): Monitor the lid and replace when condition deteriorates further.

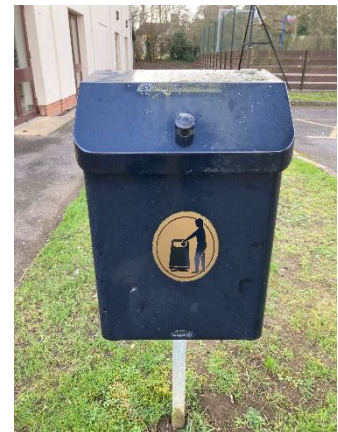
Asset: General Waste Bin

Condition: Fair

Condition notes: Evidence of rust at hinges on the lid

Recommendations for remedial work (if any): Monitor condition of lid.

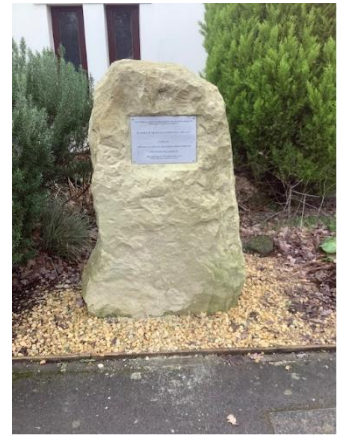
Asset: Commemorative stone

Condition notes: Some weathering of stone as expected.

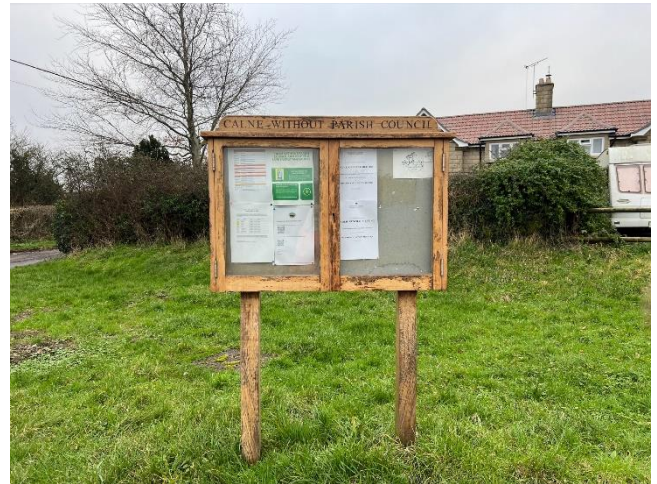
Asset: Stockley Noticeboard

Condition notes: Could do with a sand and varnish.

Recommendations for remedial work (if any): maintain annual maintenance (clean and re-oil).

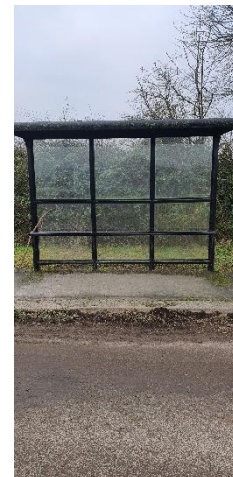
Asset: Bus Shelter

Condition notes: Dirty condition, mould and moss growing on top

Recommendations for remedial work (if any): Needs to be cleaned.

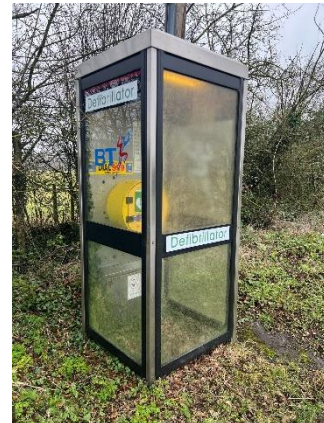
Asset: Stockley Phone Kiosk

Condition: Fair

Condition notes: Fundamental condition is good, but cobwebs inside, mould growing on Perspex panels and ivy growing across the floor.

Recommendations for remedial work (if any): Would benefit from a clean-up to remove mould, plus removal of ivy from floor and around base.

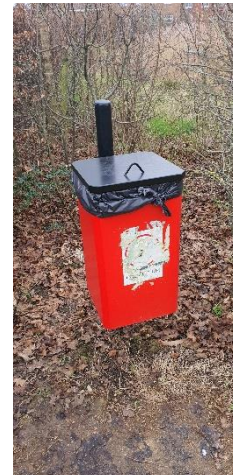
Asset: Dog Waste Bin
Location: Footpath off The Rise, Cherhill View
Ward: Middle Ward
What3Words Location: relocated.perfect.slimy
Date of Assessment: 13th January 2024
Description: Red dog waste bin.
Condition: Fair
Condition notes: Sticker could be replaced on the front
Recommendations for remedial work (if any): regularly full (but emptied twice a week)

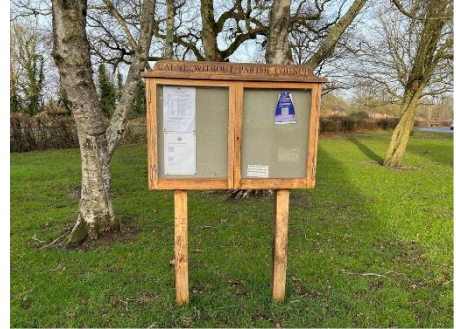
Asset: Lower Compton Notice Board

Condition notes: Perspex replace in the last year.

Recommendations for remedial work (if any): Wood will probably need some treatment in the summer.

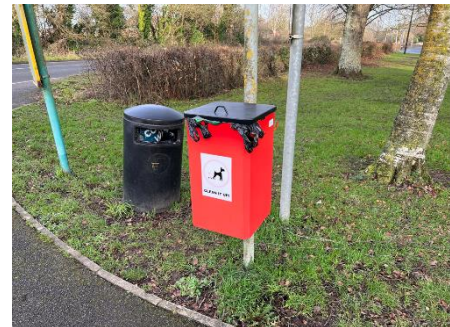
Asset: Dog waste bin

Condition notes: Some flaking paint, and bin overflowing with waste.

Recommendations for remedial work (if any): Increase emptying frequency, monitor condition of bin over the next year.

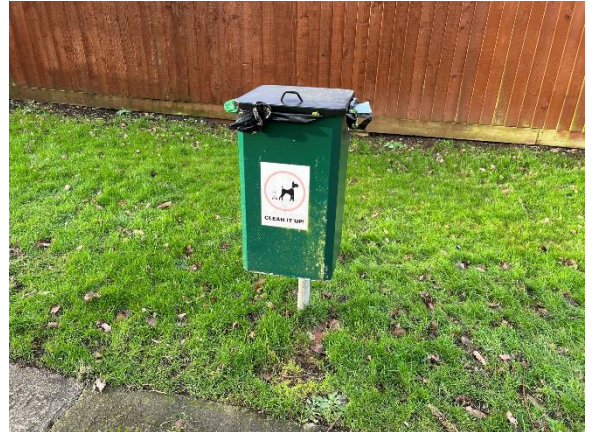
Asset: Dog waste bin
Location: Whittle Avenue, Lower Compton
Ward: East Ward
What3Words Location: wakes.blurs.watch
Date of Assessment: 24th January 2024
Description: Green dog waste bin.
Condition (delete as applicable): Very Good
Condition notes: No issues.

Recommendations for remedial work (if any): increase frequency of emptying to avoid bin overfilling.

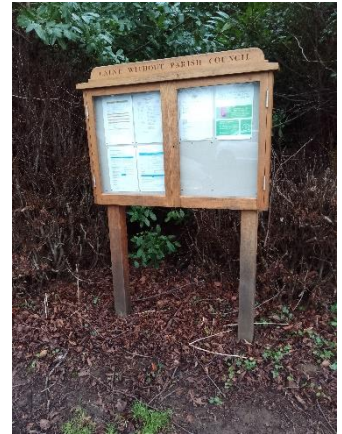
Asset: Sandy Lane Noticeboard

Condition notes: Board has weathered in over the last year, no issues.
